FLOOD PROOFING TESTS

Tests of Materials and
Systems for Flood
Proofing Structures

August 1988

US Army Corps of Engineers

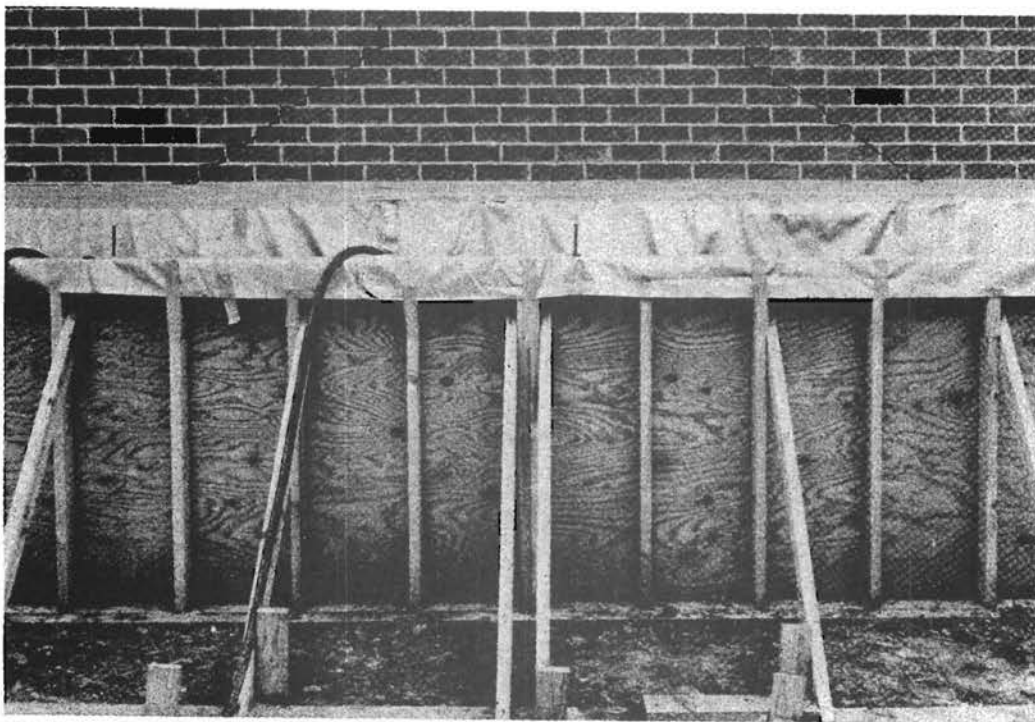
A severe loss of integrity began at 2 ft of water with complete loss occurring at 2.4 ft (Figure 8). The failure at 2.4 ft of water is presented in Figures 10 and 11.

Figure 10. Wall 1. Failure pattern of wall

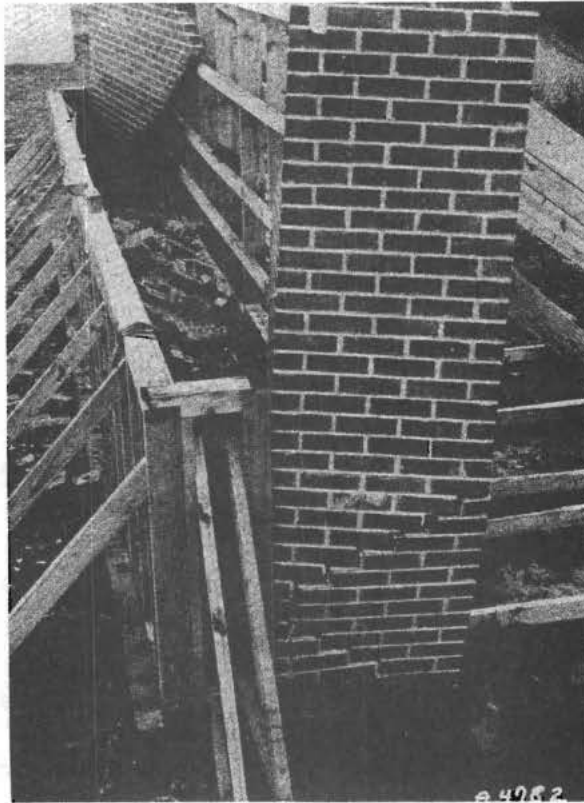
Figure 11. Wall 1. Wall failure

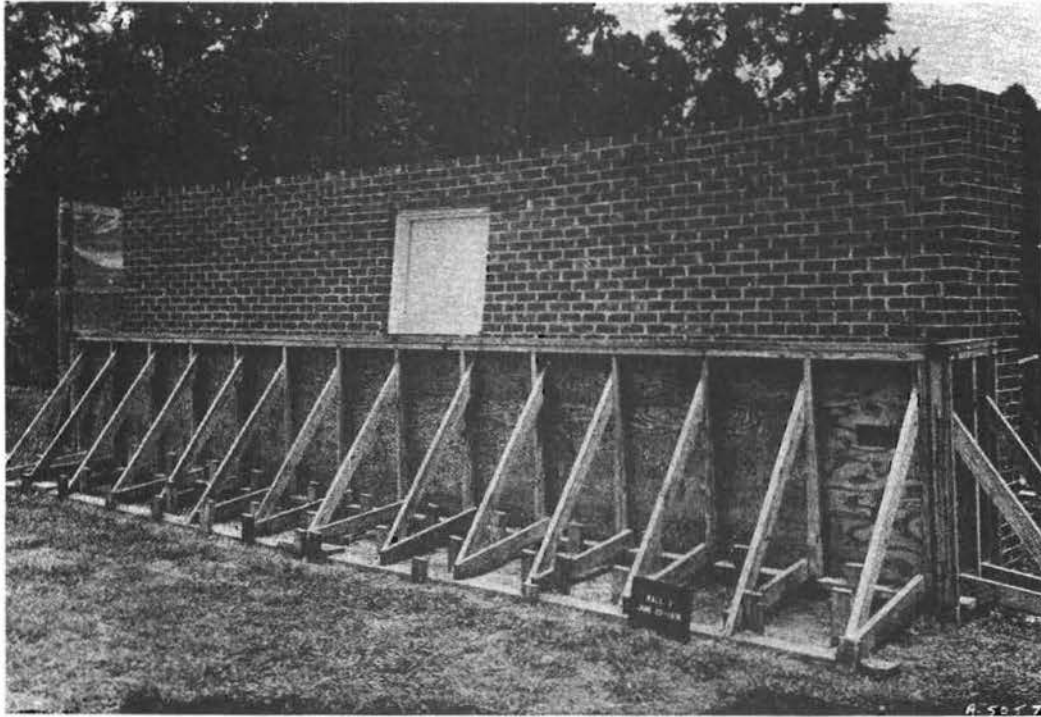
The wall deflected forward for low water loads because cord lengthening in the vicinity of the loading caused the upper part of the wall to cup forward. In an actual home, the finishing materials on the inside of the studs will give support to the wall and allow it to experience a deeper water loading than indicated by these tests. Computer solutions could be used to determine the effect of such restraints. The significant point is that the deflections recorded for Wall 2 at a given water depth should be an upper bound of deflections experienced in an actual brick-veneer house under the same loading. The failure of Wall 2 is shown in Figures 13 and 14.

Figure 13. Wall 2. Wall failure, front view

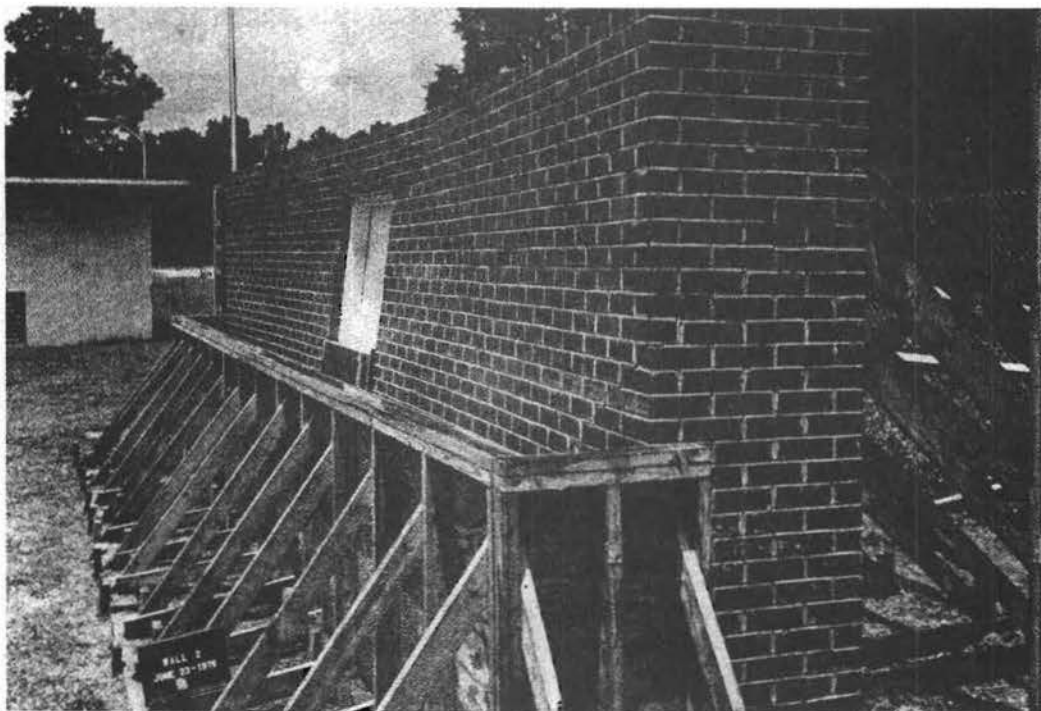
Figure 14. Wall 2. Wall failure, side view

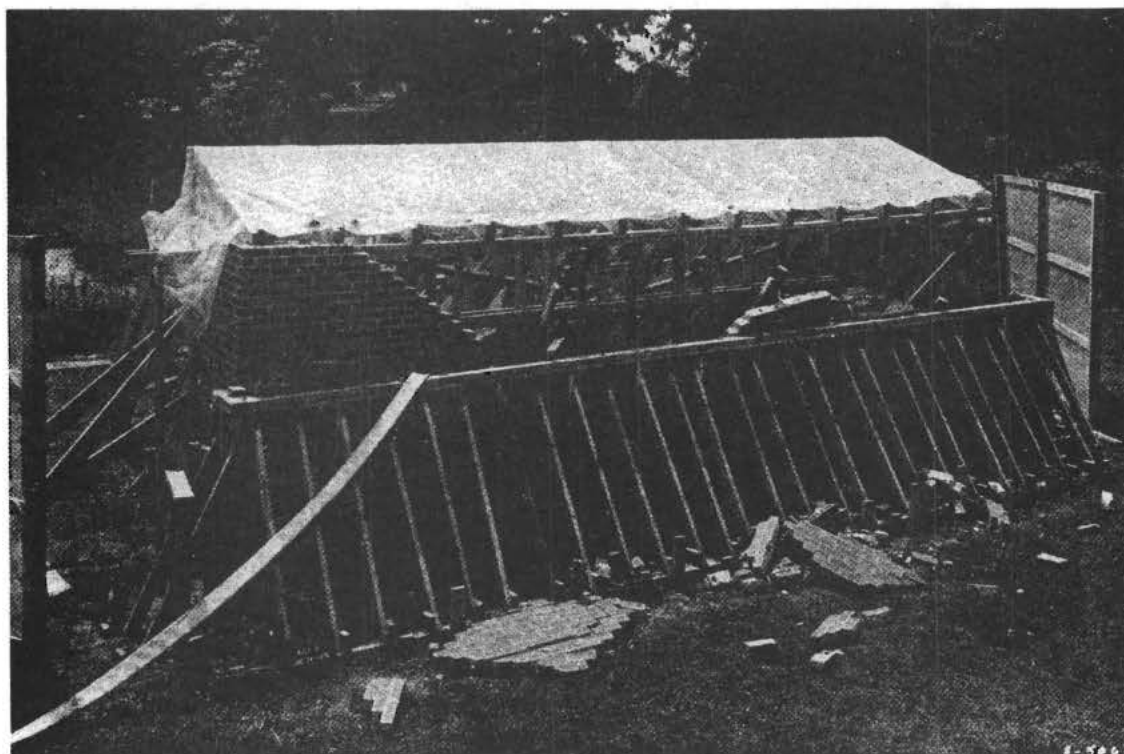
Total collapse of the brick-veneer wall occurred at a depth of 57 in. and at a total applied force of 18,300 lb. This failure was sudden and resulted from the failure of the supporting studs. The remains of the brick-veneer wall after failure are presented in Figures 16 and 17.

Figure 16. Wall 3. Wall failure, front view

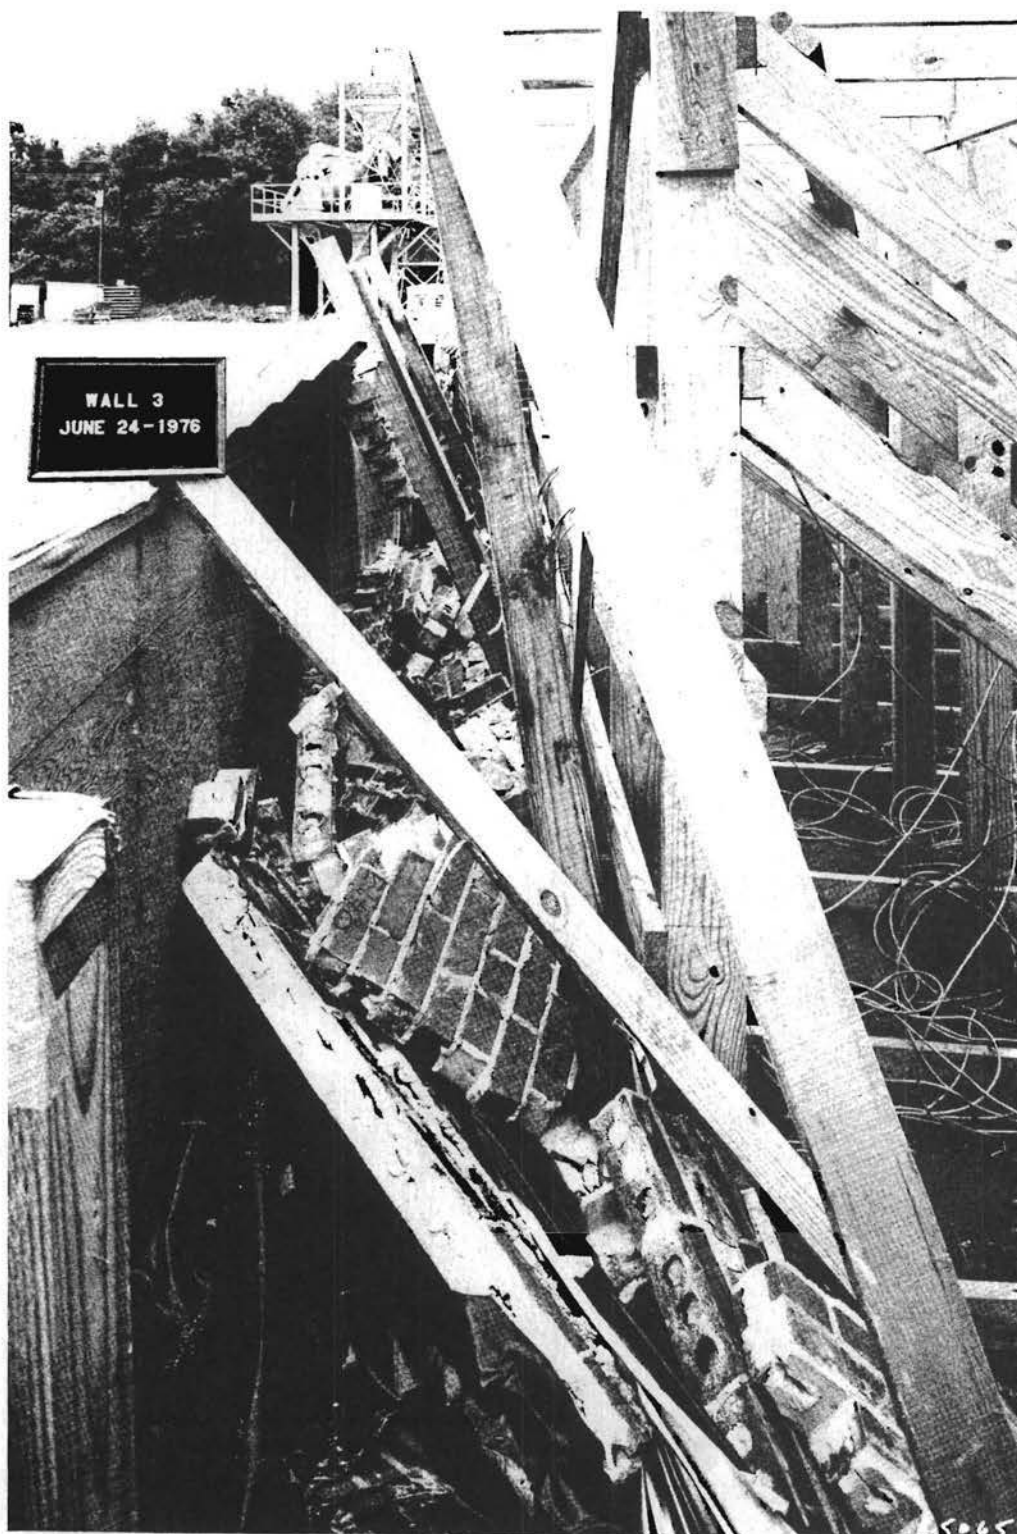
Figure 17. Wall 3. Wall failure, side view

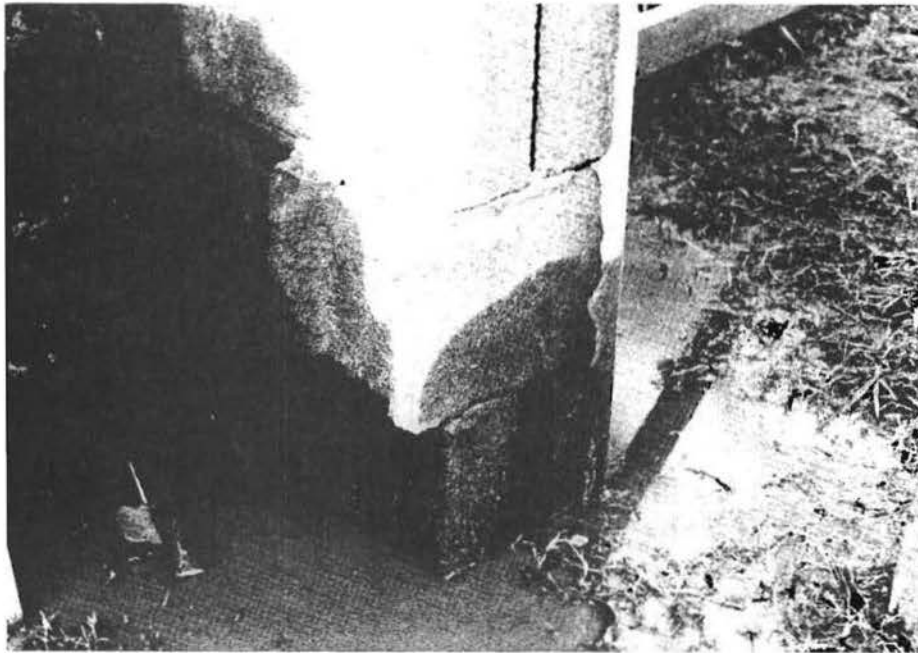
Typical deflection data for Block Wall 1 are presented in Figure 20. As the water level was raised against the surfaced wall, the plaster was weakened and was penetrated by the water; thereby reducing its effectiveness in strengthening the wall against deflection. At a water depth of 3-1/2 ft the block wall was cracked and leaking so badly that the trough could not be kept filled with water from a fire hose connected to the fire hydrant. Water flowed through the cracks faster than it could be put into the trough. Photographs of the leakage are shown in Figure 21.

b. Base of wall

Figure 21. Leakage through block wall

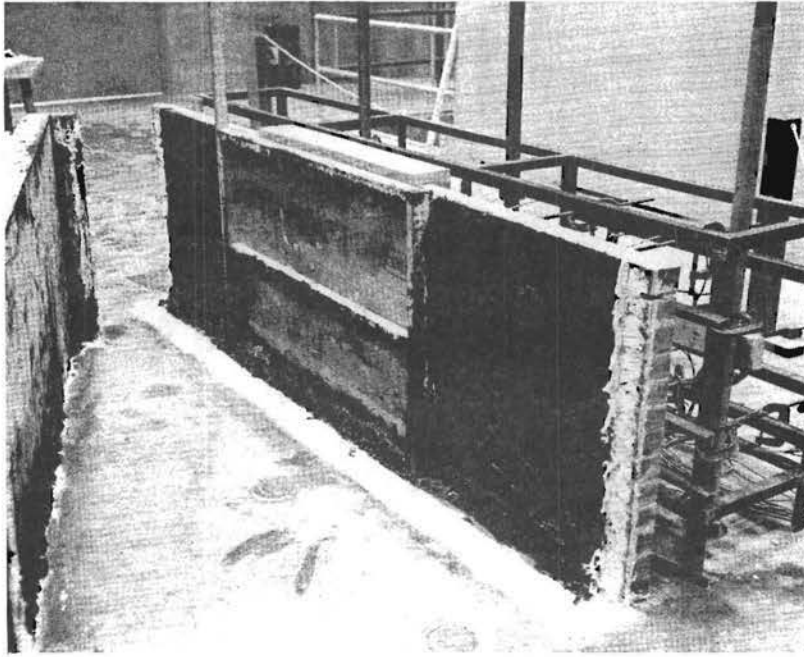
3	Same as Tests 1 and 2.	Coated with asphalt cement. Figure 37 shows the wall after the test.	The wall continued to leak in a couple of places. After the bulkhead was removed, no flaws could be observed in the asphalt cement coating in areas where the wall leaked. This implies that great care must be exercised, even if asphalt cement is put on the wall, or water will penetrate the house. The wall leaked so badly that the closure was not tested for water.

Figure 37. Brick walls coated with asphalt cement

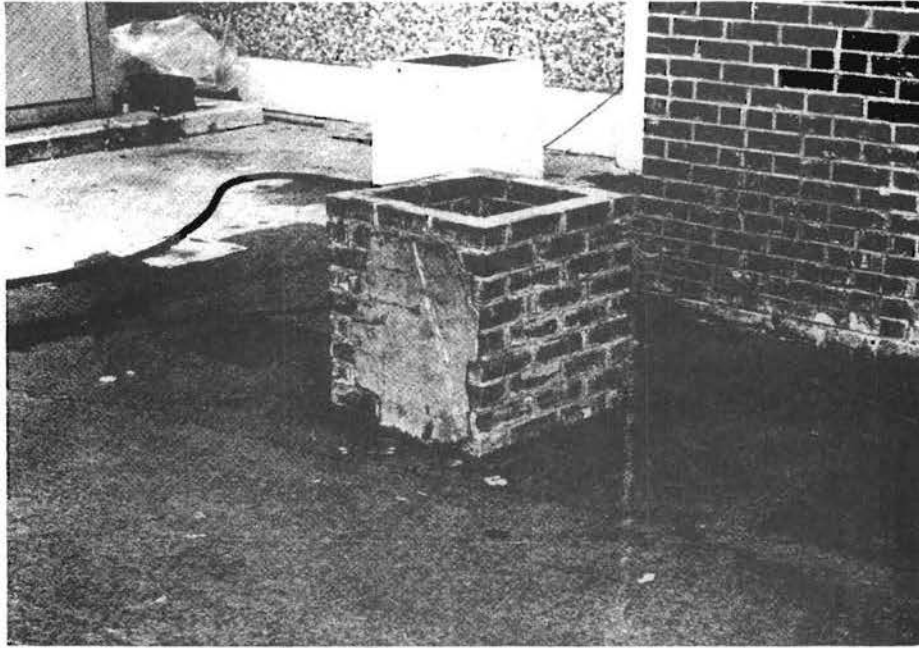
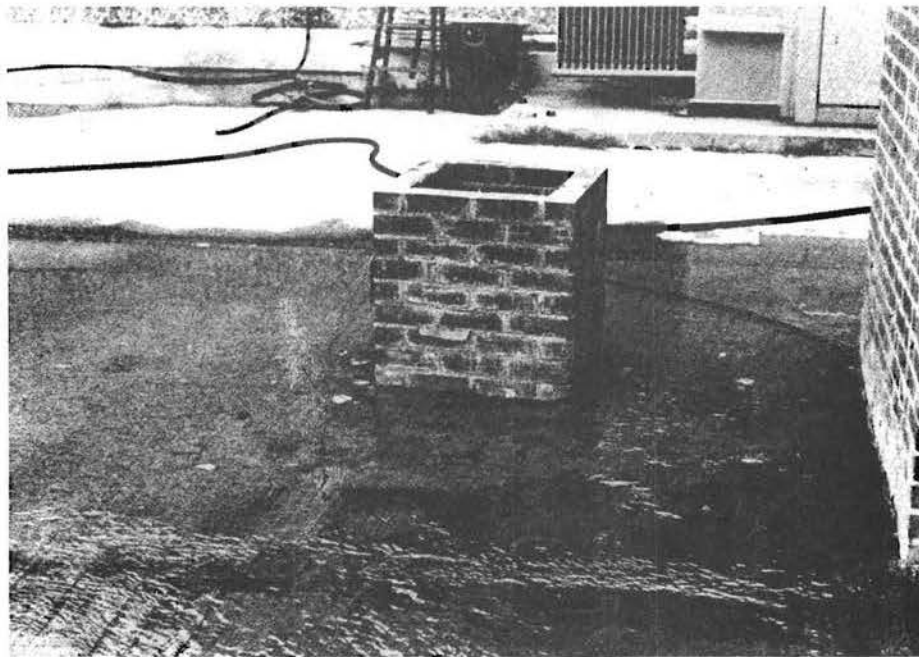
Figure 46. Failure of coating 4

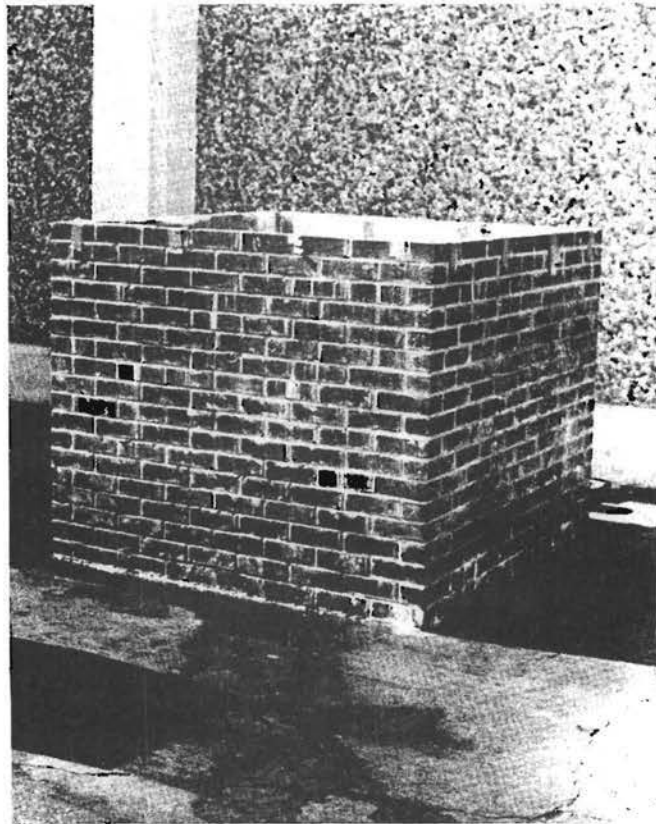
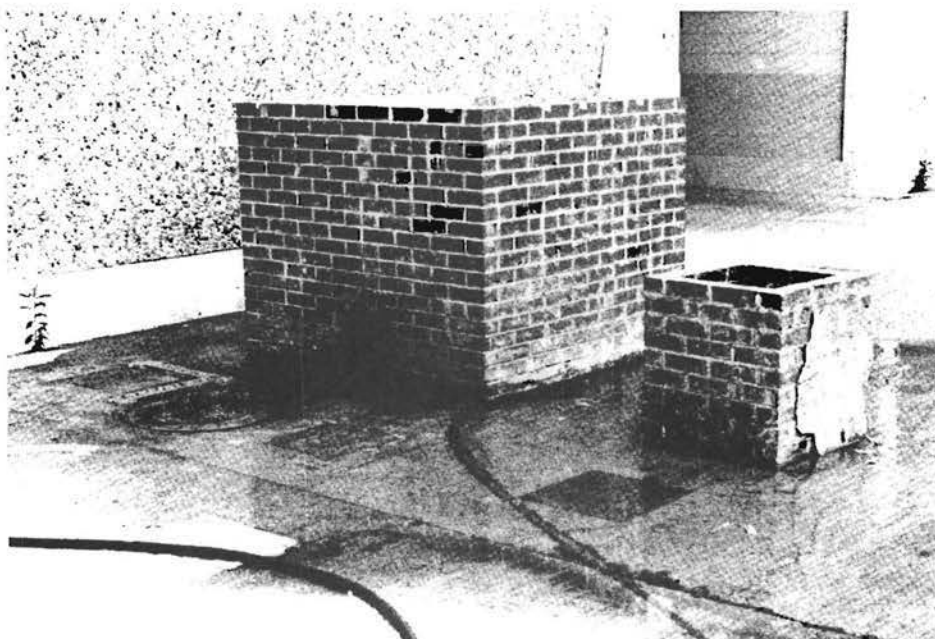
Figure 52. Dye in water leaking from large brick cube

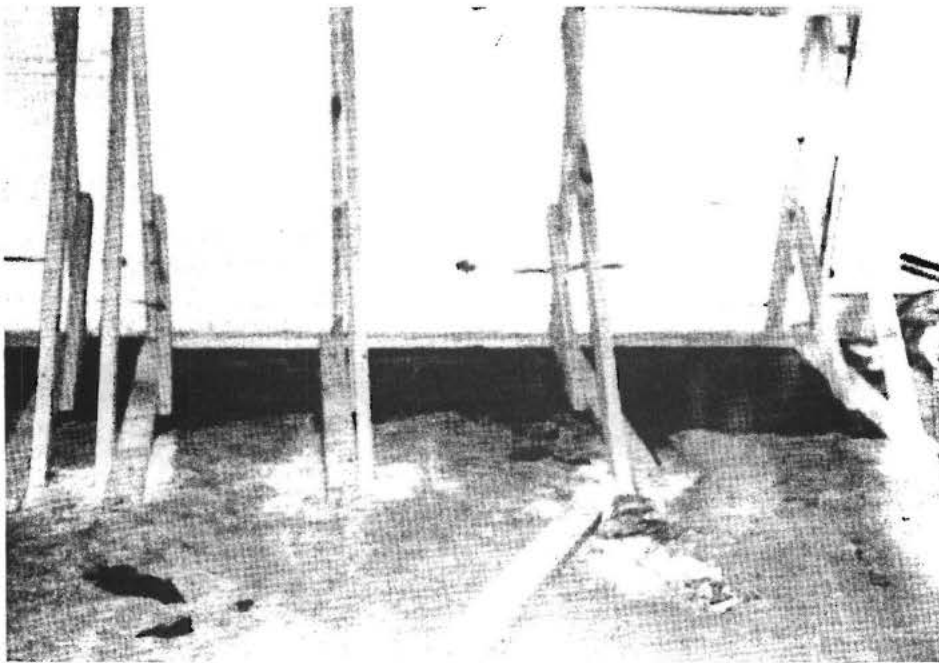
Figure 73. Water seeping under garage door due to excessive water height in sump

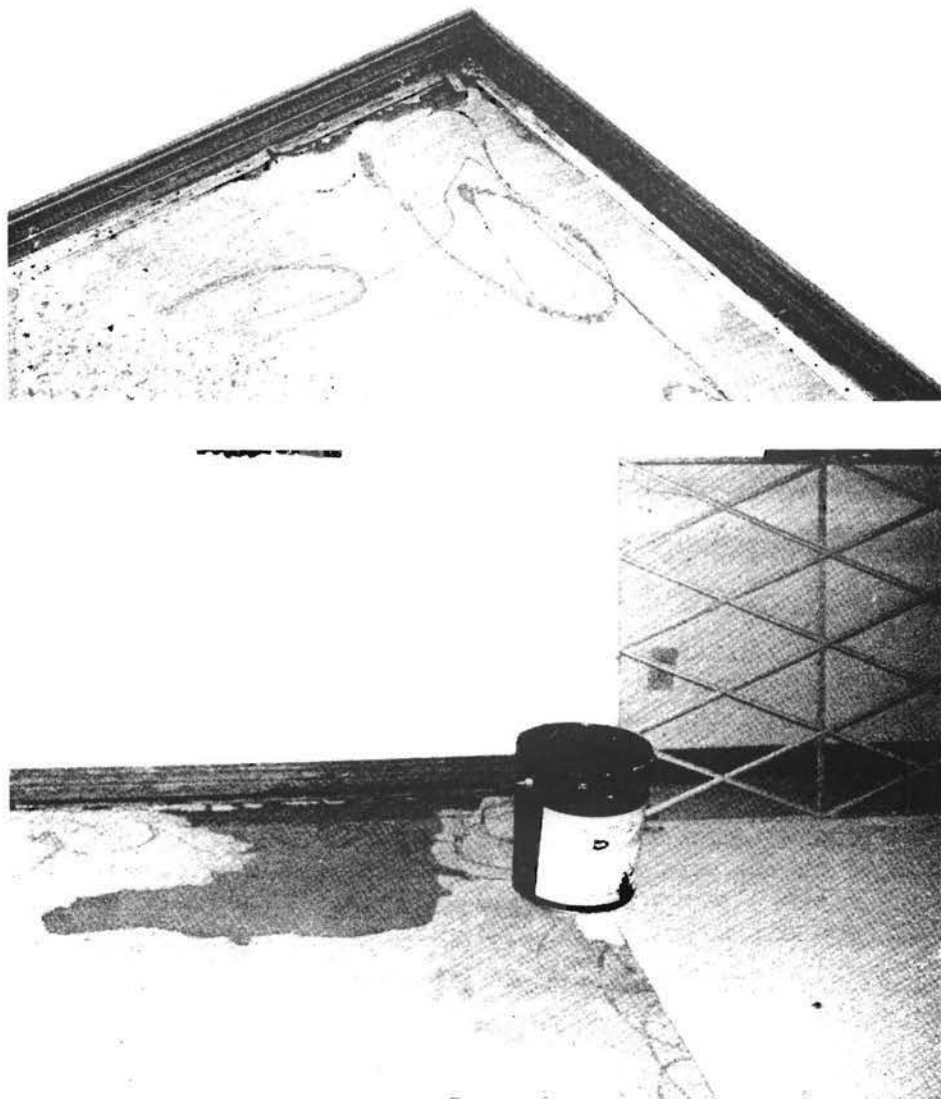
Figure 74. Seepage along baseboard due to leak in lap of fabric
